ST-8E Shutter Error and Correction

John Smith

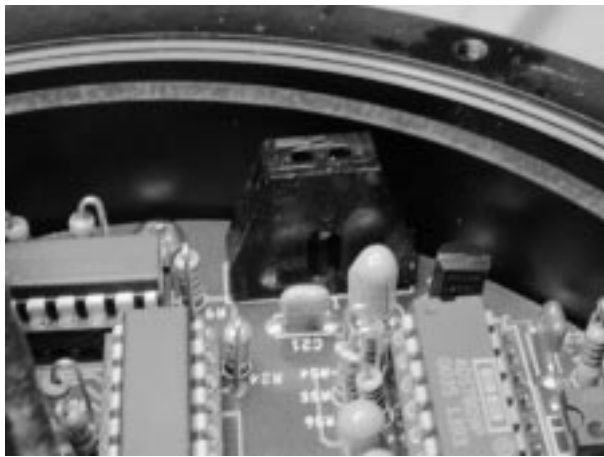
The shutter position is sensed by an emitter-detector optical detector that senses reflection from a piece of aluminum tape that is attached to the inside front cover of the camera. The shutter consists of a large thin disk with two openings opposite each other. The shutter opening that is opposite the main CCD imager allows or interrupts the detection of this reflection opening as the shutter rotates. The intent of the correction is to move the reflector closer to the detector to increase the signal.

Shutter detector

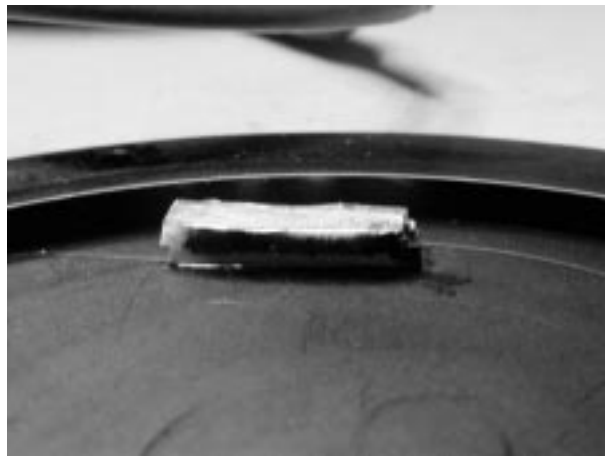
Improved shutter reflector

In order to reduce the shutter error, SBIG suggested moving the aluminum tape reflector closer to the shutter detector. The reflector is located on the inside of the bottom of the front cover of the camera. It was suggested to move it up to .15" closer, in order to provide a larger signal to the detector. Adding two thicknesses of foam tape on the existing aluminum tape and then sticking an additional piece of aluminum tape at the top of the stack accomplished this. I made sure the height of the stack was still comfortably below the surface of the cover, in order not to impede the shutter rotation. I was warned that this might lead to shutter detector light being reflected into the main CCD detector. The path was off the right angle prism that is used for the tracking detector, up on to the filter then reflected back off the filter and thence to the detector.

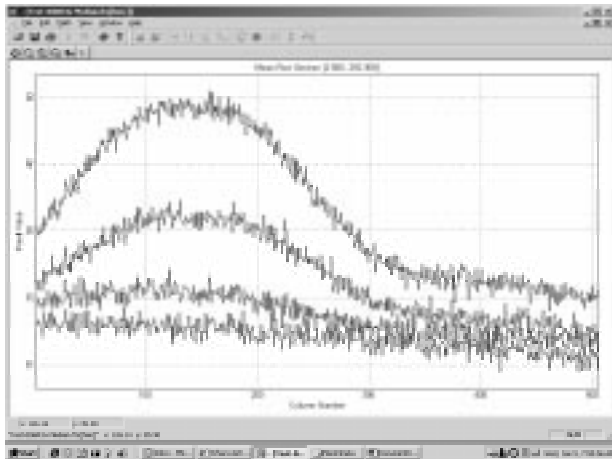
In the curves below, the highest peak was that of the red filter, next was the green, then the blue then the clear. These curves were taken in Mira AP.

Peak row scan

In looking at a bright light reflected from the filters, the intensities above seem reasonable, i.e., the red and green reflect the greatest and the blue less and the clear the least. I suspect AR coatings on the filters would minimize this issue. These are extremely small values, indicating the sensitivity of the detector. Nevertheless this will affect camera data and should be corrected.

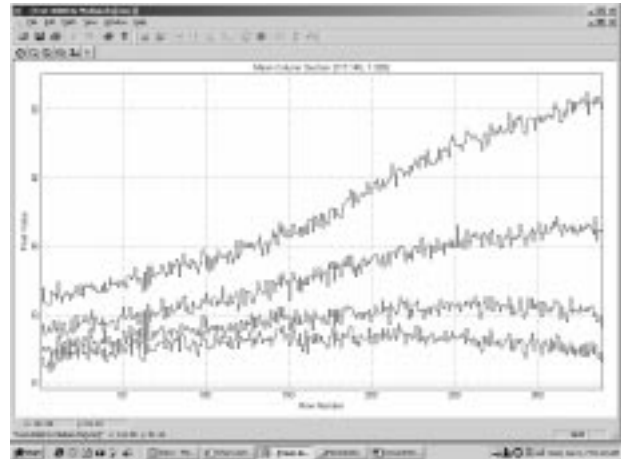
Peak column scan

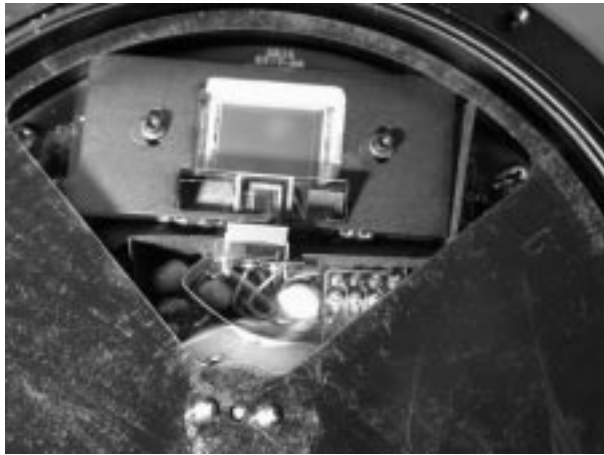
Baffle, top view

Two light baffles as illustrated below were fabricated using manila folder material that had been “painted” with a black, permanent felt pen. These were placed on either side of the tracking CCD and formed to go around components as required. The baffles were tack-glued to the top of nearby orange tantalum capacitors.

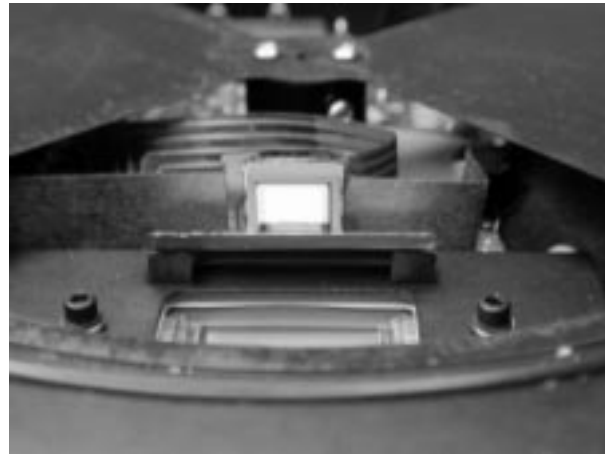
Baffle, front view

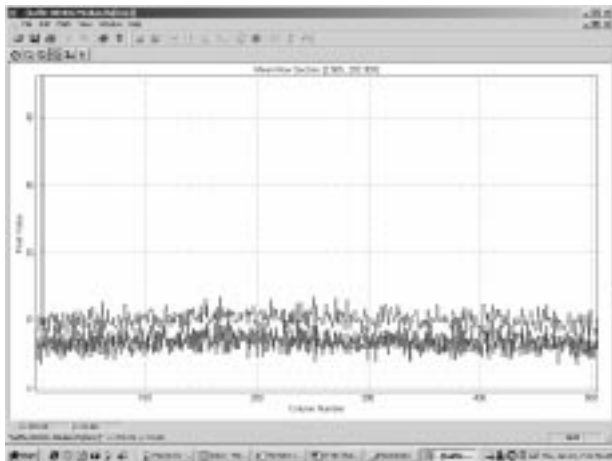
Row scan

The above data for all four filters shows the same regions as prior to installation of the baffles. There is no sign of spurious illumination of the imager. Aperture scans for maxima and minima gave the following results:

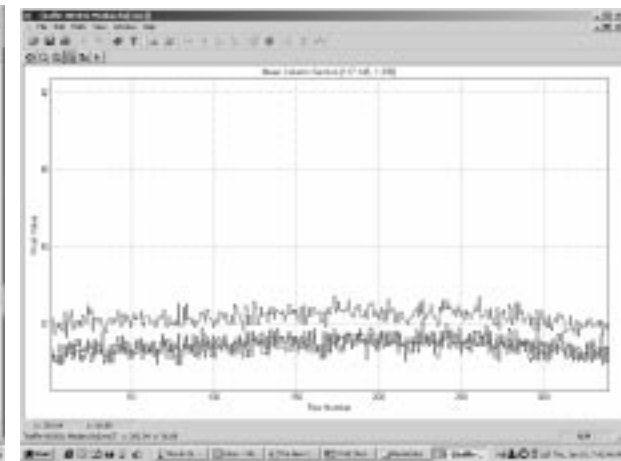
Column scan
